Historical Resources Evaluation - Piedmont Corporation Yard

July 13, 2023  
Rincon Project No. 21-11542

**Subject: Historical Resources Evaluation - Piedmont Corporation Yard**

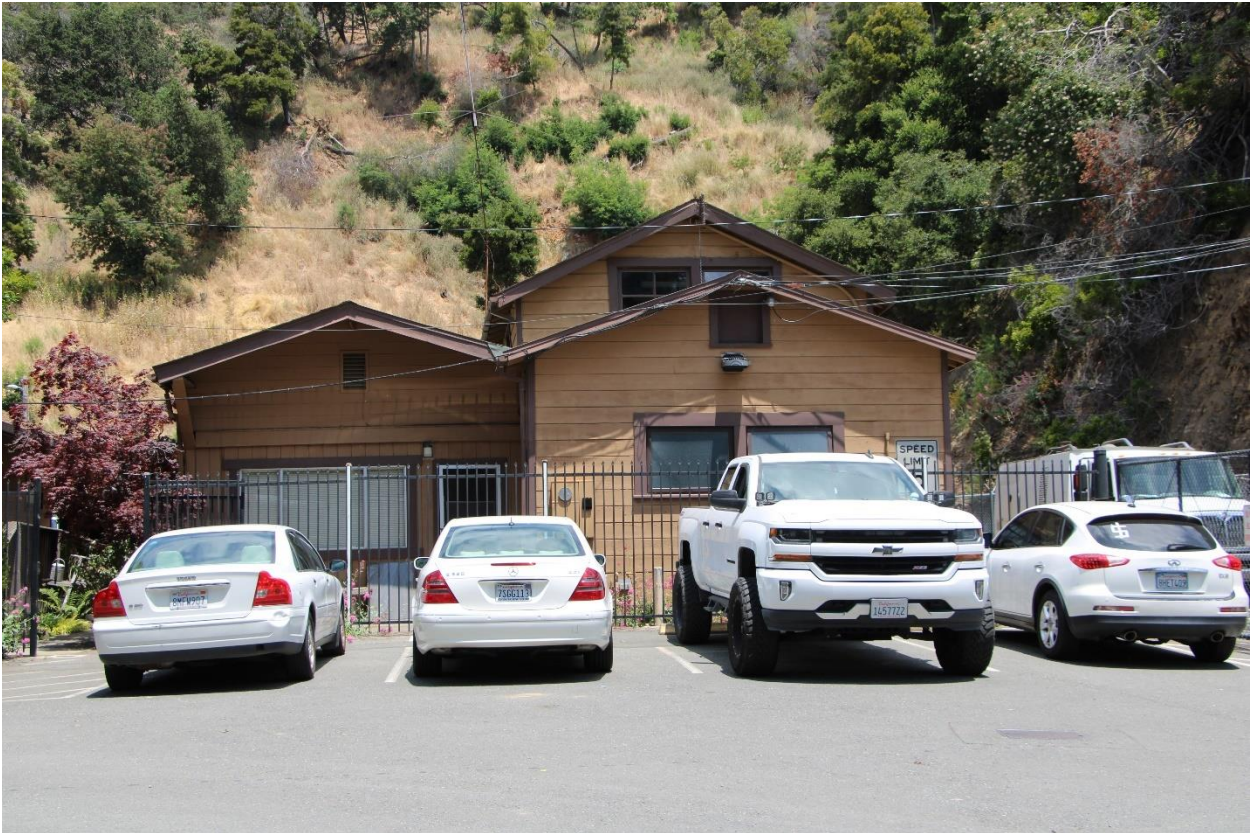
**Figure 4 Primary Elevation of Maintenance Building, Camera Facing North**

The maintenance building is one-to-two story wood frame building situated on a concrete base at the east end of the site (Figure 4). It appears to be the result of several additions and its primary elevation features three front-facing gables – two one-story gables with a two-story gable rising above. It has a wood plank exterior and an asphalt shingle roof. The primary, southern portion of the building appears to be office space, while the rear is garage with loft space above. The east elevation features an exterior wood stair to access the loft space above the garage. The building's rear elevation includes a ground story garage entry topped with a deep eave plywood awning, which appears to be a later addition. The area above the garage includes a closed paired opening with a hoist beam above. The elevation continues to a one-story section of the building with a short gambrel-shaped overhang above a sliding glass door entry. The building's south elevation is comprised of the building's one-story portion. The building appears to be the result of several additions, revisions, and accretions over time and as a result has a mix of horizontal and vertical wood siding, modern horizontal slide and historic awning casement windows, and multiple entries.

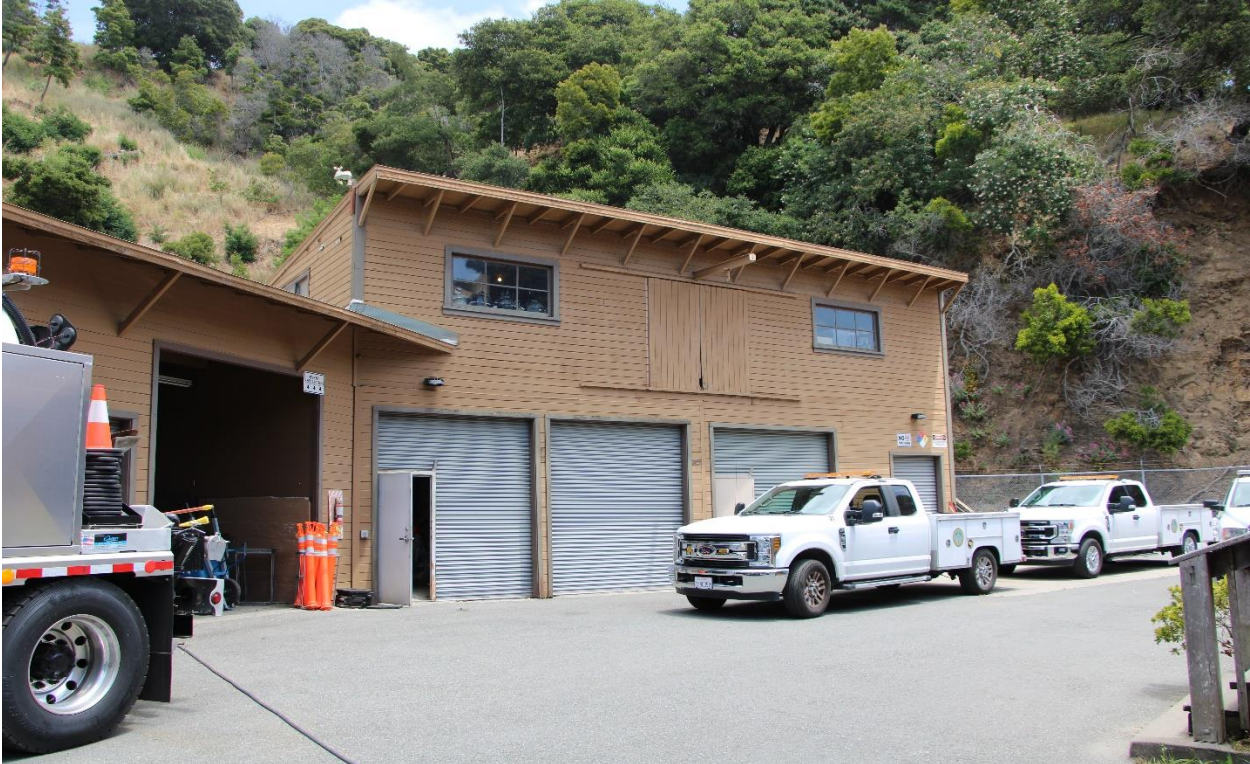
**Figure 5 Primary Elevation of Garage Building, Camera Facing Northeast**

The garage building is a one to two story building and features a skillion roof that slopes toward the rear of the building with overhanging eave at the primary, south elevation for the length of the building (Figure 5). It has a horizontal wood plank exterior. As described above, the building has an irregular, U-shaped footprint. It continues for 11 bays – four bays at the eastern, two-story portion; a one bay breezeway followed by three bays at the center; and three bays at the western end. The two-story portion has three garage entries with metal rollup doors and one man door with a rollup door at the ground floor with two three-over-three wood frame windows flanking a wood horizontal slide door below a hoist beam at the second floor. The second floor is accessed via an exterior wood stair at the building's east elevation, which also features a two-over-two wood window. The remainder of the building features additional roll-up doors at each bay described above, with the exception of the breezeway between the one- and two-story portions of the building, which provides access to the rear of the building. The rear of the is devoid of openings or ornamentation. The building's west elevation includes an additional vehicular bay.

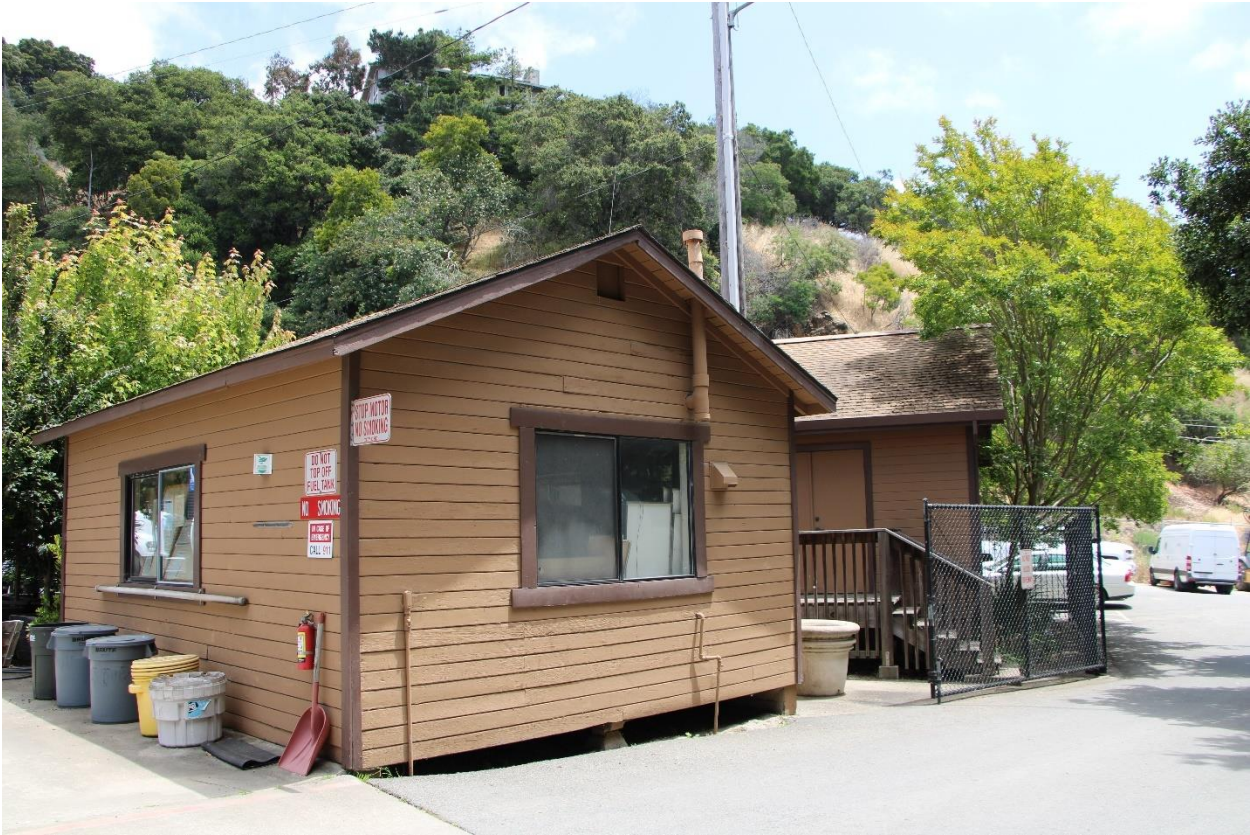
Figure 6 Primary and West Elevation of Shed Building, Camera Facing Northeast

The two buildings at the western end of the site include the shed and office buildings. Adjacent to a vehicle gas pump, the shed building is a one-story wood frame building with a gable roof and wood plank exterior (Figure 6). It has aluminum horizontal slide windows on each elevation, and a rear entry door at its north elevation. The office building is between the shed and the maintenance building (Figure 7). It is a one-story wood frame building with a gable roof and horizontal wood plank exterior. A deep eave overhangs above the east elevation, covering a concrete ramp with wood railing below. The elevation includes two entry doors. A short stair at the north elevation provides access to a third

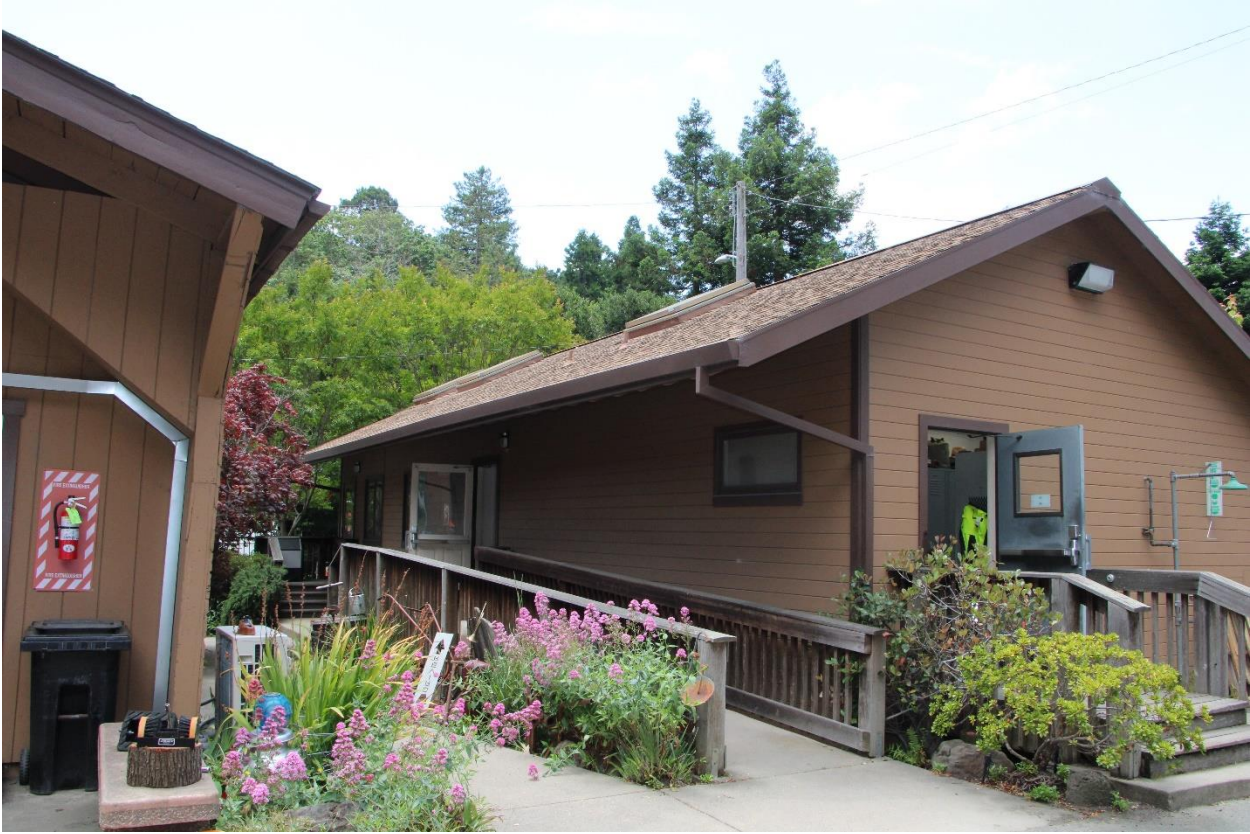
Figure 7 Rear and East Elevation of Office Building, Camera Facing Southwest

entry. The west elevation has a short wood stair to a paired door entry and includes two horizontal slide windows. The south elevation includes two horizontal slide windows.

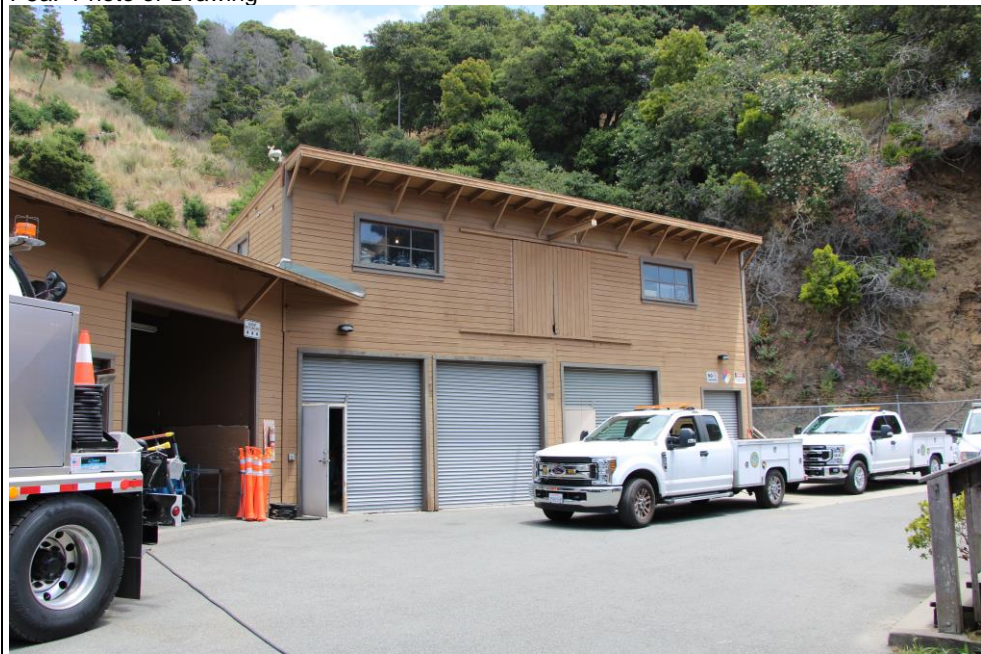
P5a. Photo or Drawing

P5b. Description of Photo:  
Primary (south) Elevation of Garage  
Building, Camera Facing Northeast

The garage building is a one to two story building and features a skillion roof that slopes toward the rear of the building with overhanging eave at the primary, south elevation for the length of the building. It has a horizontal wood plank exterior. As described above, the building has an irregular, U-shaped footprint. It continues for 11 bays – four bays at the eastern, two-story portion; a one bay breezeway followed by three bays at the center; and three bays at the western end. The two-story portion has three garage entries with metal rollup doors and one man door with a rollup door at the ground floor with two three-over-three wood frame windows flanking a wood horizontal slide door below a hoist beam at the second floor. The second floor is accessed via an exterior wood stair at the building's east elevation, which also features a two-over-two wood window. The remainder of the building features additional roll-up doors at each bay described above, with the exception of the breezeway between the one- and two-story portions of the building, which provides access to the rear of the building. The rear of the is devoid of openings or ornamentation. The building's west elevation includes an additional vehicular bay.

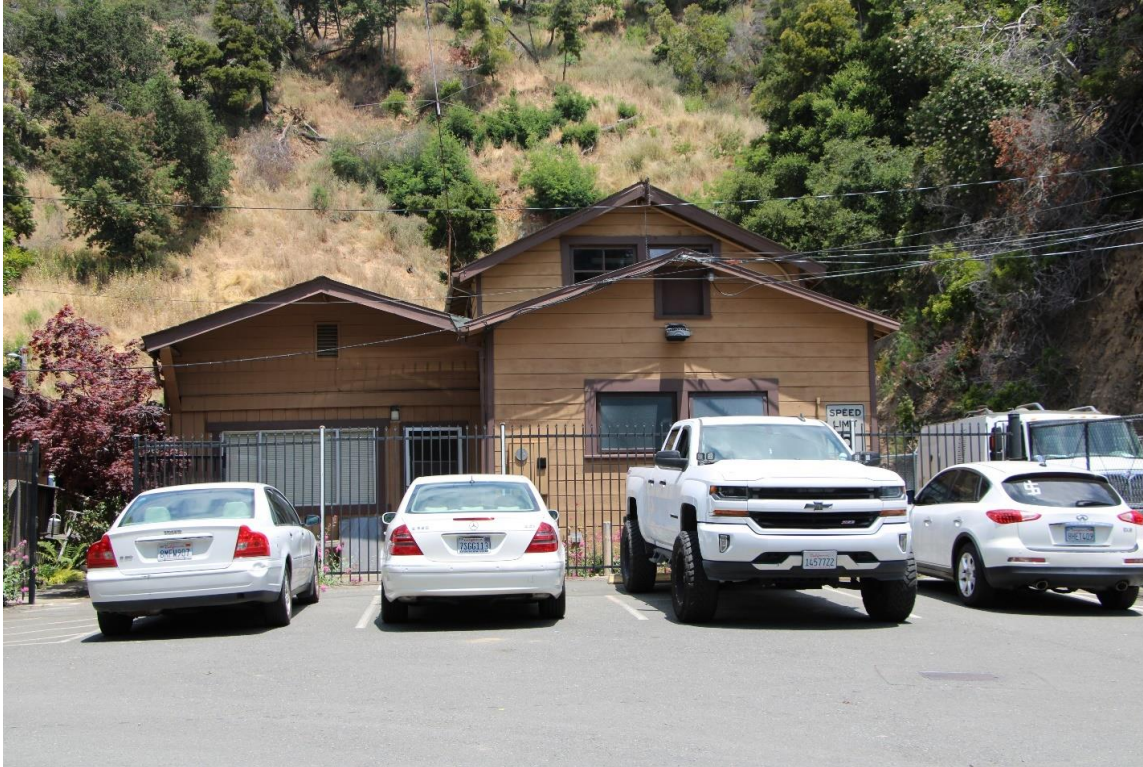
Primary Elevation of Maintenance Building, Camera Facing North.

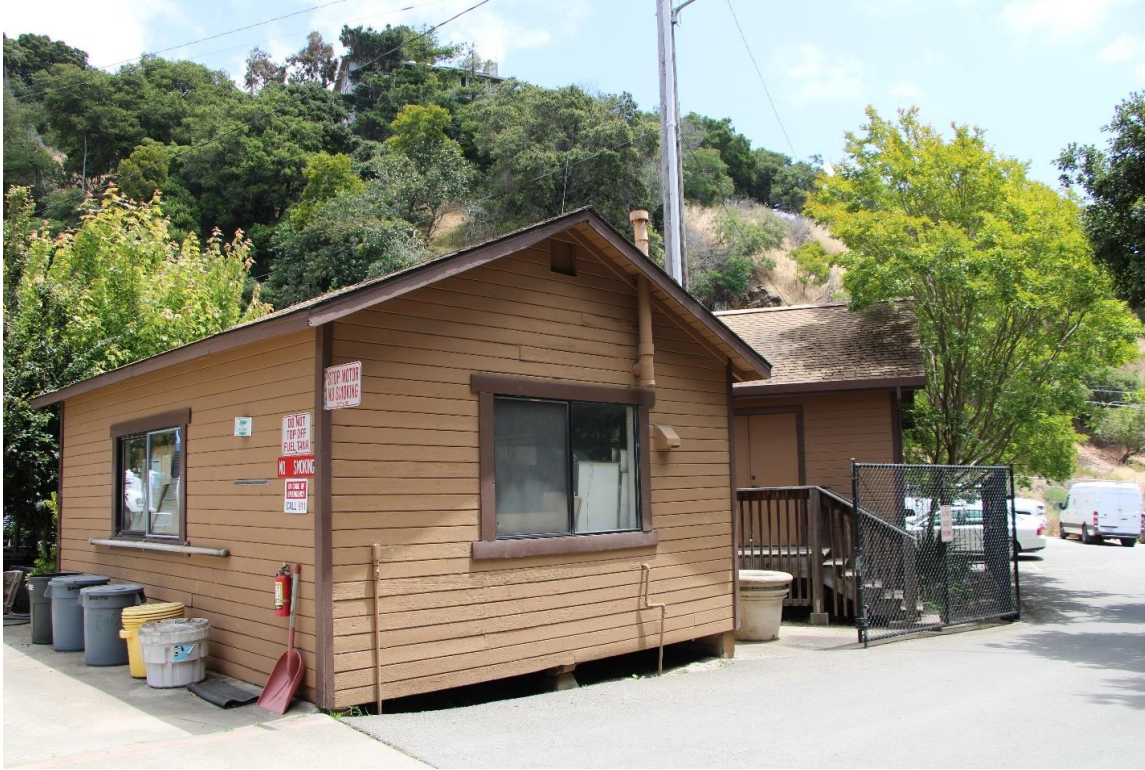
Primary and West Elevation of Shed Building, Camera Facing Northeast.

The two buildings at the western end of the site include the shed and office buildings. Adjacent to a vehicle gas pump, the shed building is a one-story wood frame building with a gable roof and wood plank exterior. It has aluminum horizontal slide windows on each elevation, and a rear entry door at its north elevation. The office building is between the shed and the maintenance building. It is a one-story wood frame building with a gable roof and horizontal wood plank exterior. A deep eave overhangs above the east elevation, covering a concrete ramp with wood railing below. The elevation includes two entry doors. A short stair at the north elevation provides access to a third entry. The west elevation has a short wood stair to a paired door entry and includes two horizontal slide windows. The south elevation includes two horizontal slide windows.

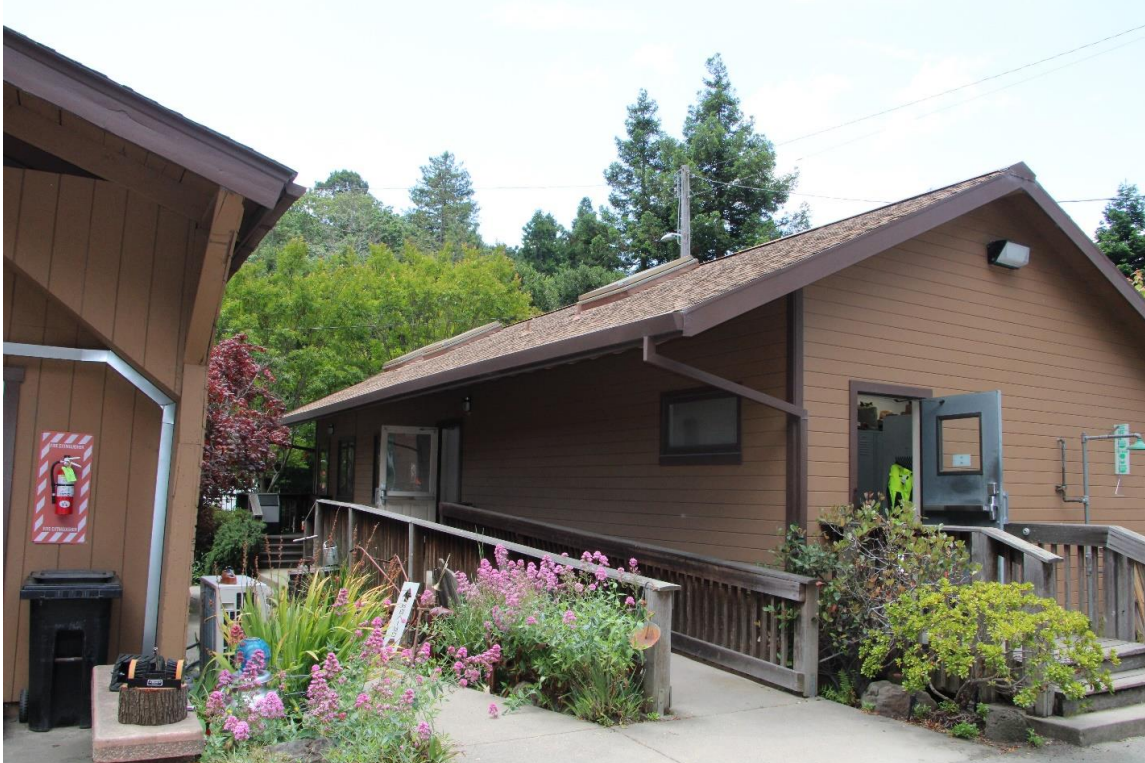
Rear and East Elevation of Office Building, Camera Facing Southwest.
